INTERNATIONAL BOUNDARY AND WATER COMMISSION
UNITED STATES AND MEXICO

Subject: Hydraulic Analysis for the Constructed Bollard Wall in the Rio Grande Floodplain near Mission, Texas

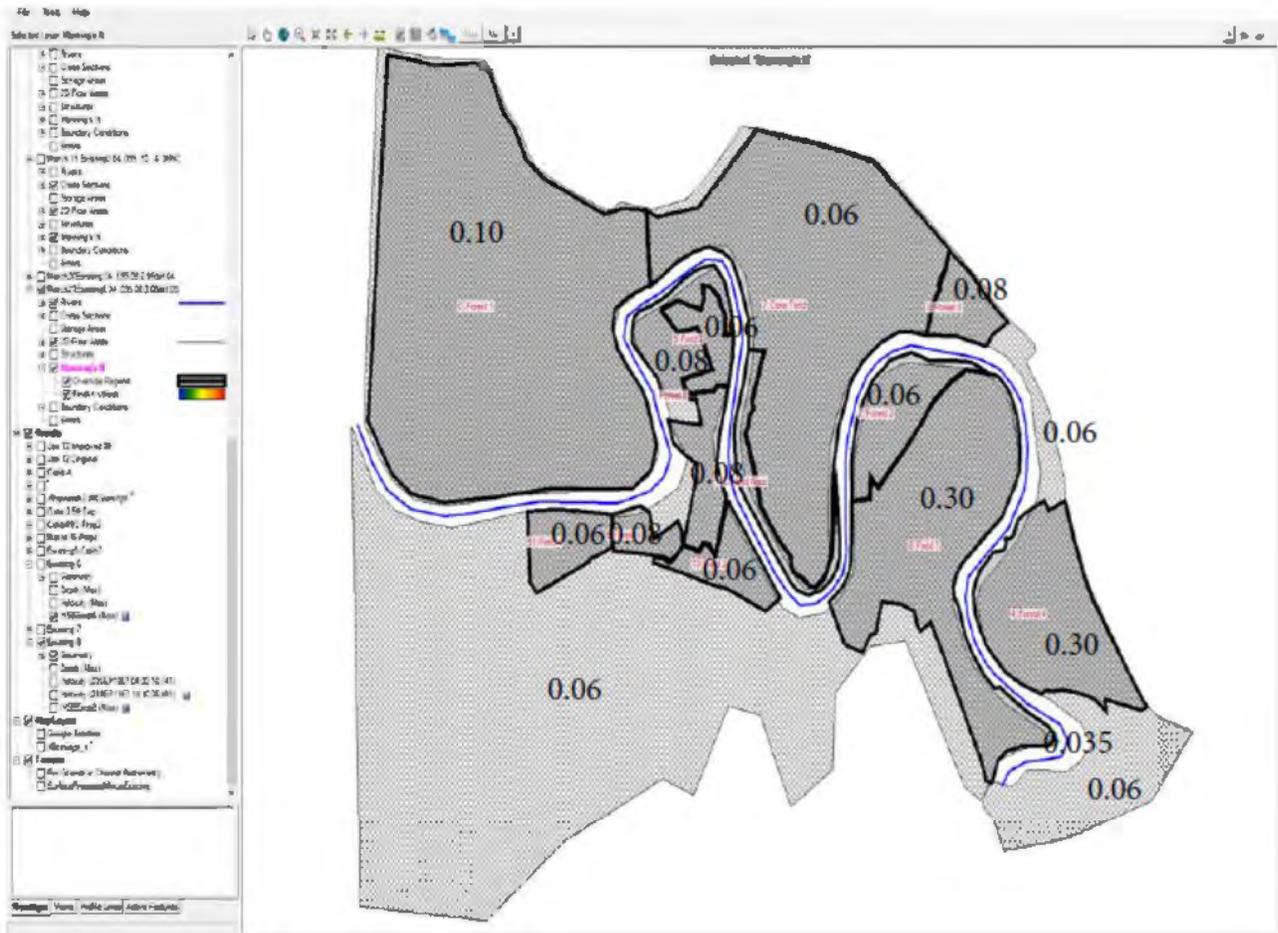
The Fisher Industries model divides the modeled area into various regions based on ground cover. We utilized the same regional grouping but adjusted the roughness values for the different regions to obtain a reasonable match of the modeled and observed WSE values for the calibration. The finalized roughness coefficient values based on the calibration model run are shown in **Figure 1**. Channel roughness value is 0.035 with 0.04 for both overbanks. Floodplain comprises row crop (corn), forest and cleared area. Roughness coefficient values for various forest areas vary from 0.08 to 0.3, including some areas with 0.10. Roughness values had to be increased to 0.3 at the downstream areas to match the observed WSE.

Figure 1: Derived Manning's Roughness Values after Calibration
